The effect of decarburization on the fatigue life of overhead line hardware

J. Calitz¹, S. Kok², and D. Delpoort³

Journal of the Southern African Institute of Mining and Metallurgy, vol. 121, no. 10, pp. 537–542

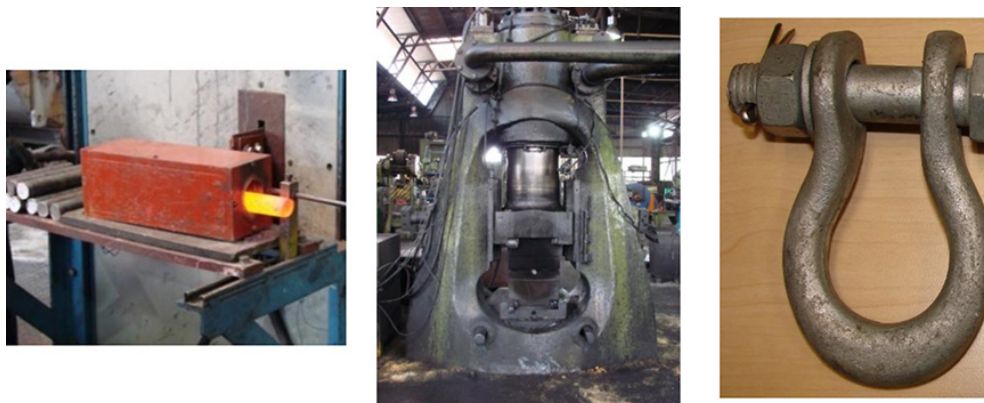
Figure 1—Induction furnace and hammer forge press used to manufacture the bow shackles

Bow shackles were hammer-forged from 35 mm diameter O80M40 (EN8) material, using a closed die system making use of a Banning pneumatic hammer forged press as depicted in Figure 1. The 300 mm long billets were induction heated between 1100°C and 1250°C and the forging temperature was between 950°C and 1250°C. The holes in the eye section were punched immediately after the component was forged.

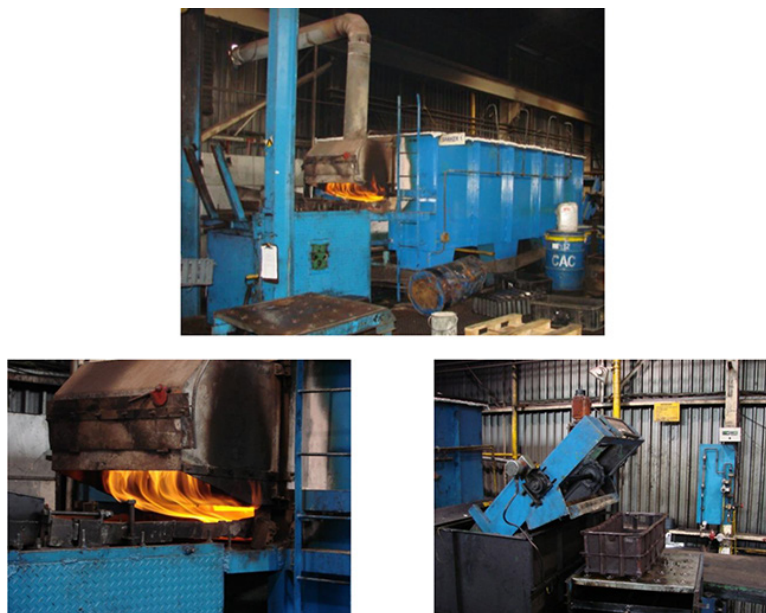
Figure 2—Furnace arrangement used for the austenitization heat treatment and quenching process

The normalizing heat treatment was conducted in a protective (controlled) atmosphere using propane gas to prevent scaling of the component surface. The shackles were placed in baskets and loaded into the preheated furnace at 820°C. Subsequently, the temperature was increased to 920°C within 75 minutes. The temperature was maintained for 2½ hours, after which the components were removed and air cooled to room temperature while still in the baskets. Figure 2 depicts the heat treatment equipment used.

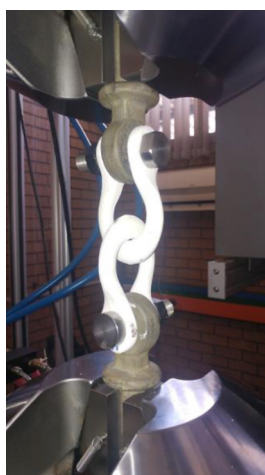
Figure 3—Shackle fatigue testing set-up

As depicted in Figure 3, a back-to-back shackle arrangement was used to simulate installation practices. The tongue fittings measuring 20 mm in thickness and a bolt hole of 20 mm was used to connect the back-to-back shackle arrangement to the MTS test machine grips.

The bolts used were not the standard 8.8 grade bolts that are supplied with the 210 kN shackles, but were machined from martensitic stainless steel, which provided improved mechanical

properties compared to the 8.8 grade material, in order to minimize the deformation associated when subjecting the bolt to bending loads when the shackle is loaded in tension.

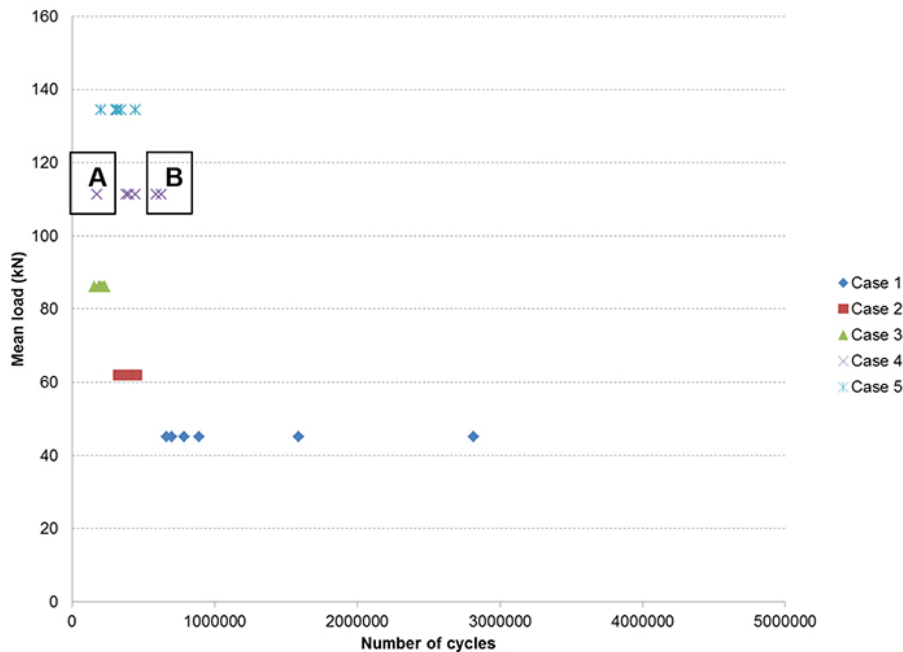
Figure 4—Mean load versus number of cycles to failure plot for 'as received' shackles

Figure 4 depicts the number of cycles to failure *versus* the mean applied load for the 'as received' shackles.

As depicted in Figure 6, shackle B had an overall lower hardness than shackle A. However, shackle B revealed better fatigue performance than shackle A, as depicted in Figure 4. This can be attributed to shackle A having a larger decarburization depth and greater hardness difference between the surface and the parent (inner) material.

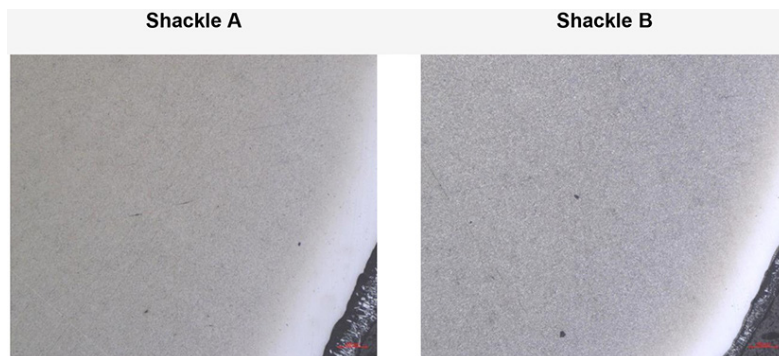
Figure 5—Difference in decarburization depth for 'as received' shackles

Figure 5 depicts the microstructures of the metallographic specimens removed from the leg section of shackle specimens A and B in the vicinity where the fatigue fracture occurred. The specimen with the higher ferrite content, namely shackle B, underwent a higher number of cycles to failure. As depicted in Figure 5, shackle B also had a decarburization depth 38% less than that of shackle A.

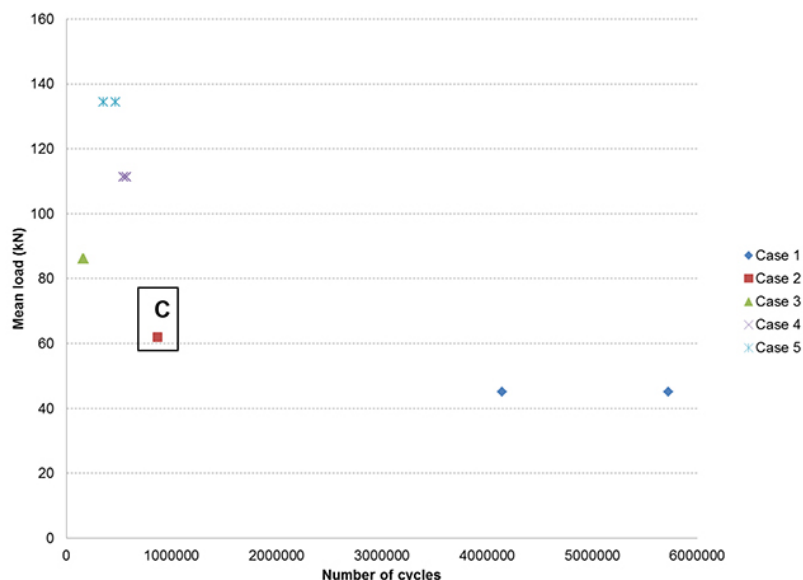
Figure 7—Mean load versus number of cycles to failure plot for HTM shackles

The altered microstructure of the HTM shackles that was obtained by the modified heat treatment resulted in an

improvement in the fatigue performance of the bow shackles for loading cases 1 and 2, as illustrated in Figure 7. No improvement in fatigue performance was gained at higher loadings. A previous study (Calitz, Kok, and Delport, 2019) concluded that the curved shape of the leg contributes towards premature fatigue failure at higher loads. The leg section is not only subjected to tensile stress when the shackle is under tension, but also to a large degree of bending stress as a consequence of its shape. The increase in bending stress with an increase in loading results in localized overstressing of the material, promoting fatigue crack initiation and propagation.

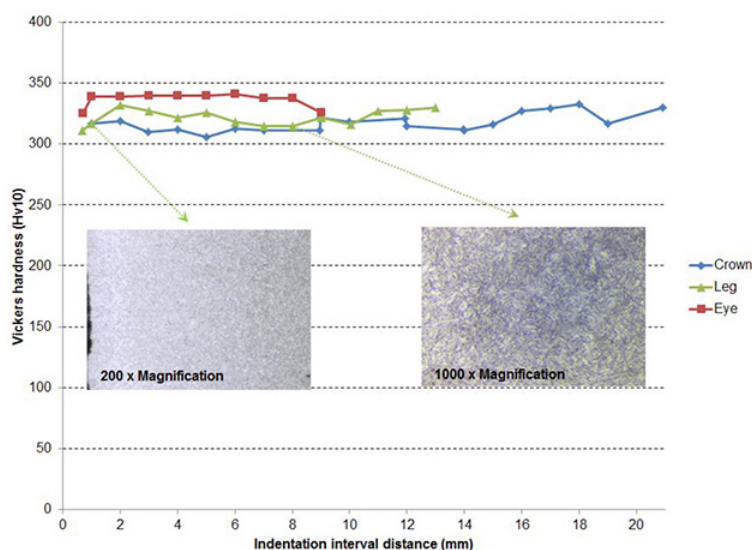
Figure 8—Hardness profiles for HTM shackle C

Figure 8 depicts the hardness profiles and micrographs taken at the leg section of shackle C. Shackle C represents the overall condition of the HTM shackles. The decarburization depth was less prominent for the HTM shackles and the hardness difference between surface and parent material was minimal compared to shackle A (Figure 6).
